PHOTOGRAPHIC TOUR OF THE BASE END STATION AT CABRILLO NATIONAL MONUMENT

This is a collection of photos that show the Base End Station and Battery Commander's bunker that is located north of the Old Point Loma Lighthouse. These photos were taken during the first quarter of 2013, after slightly more than a year of restoration.

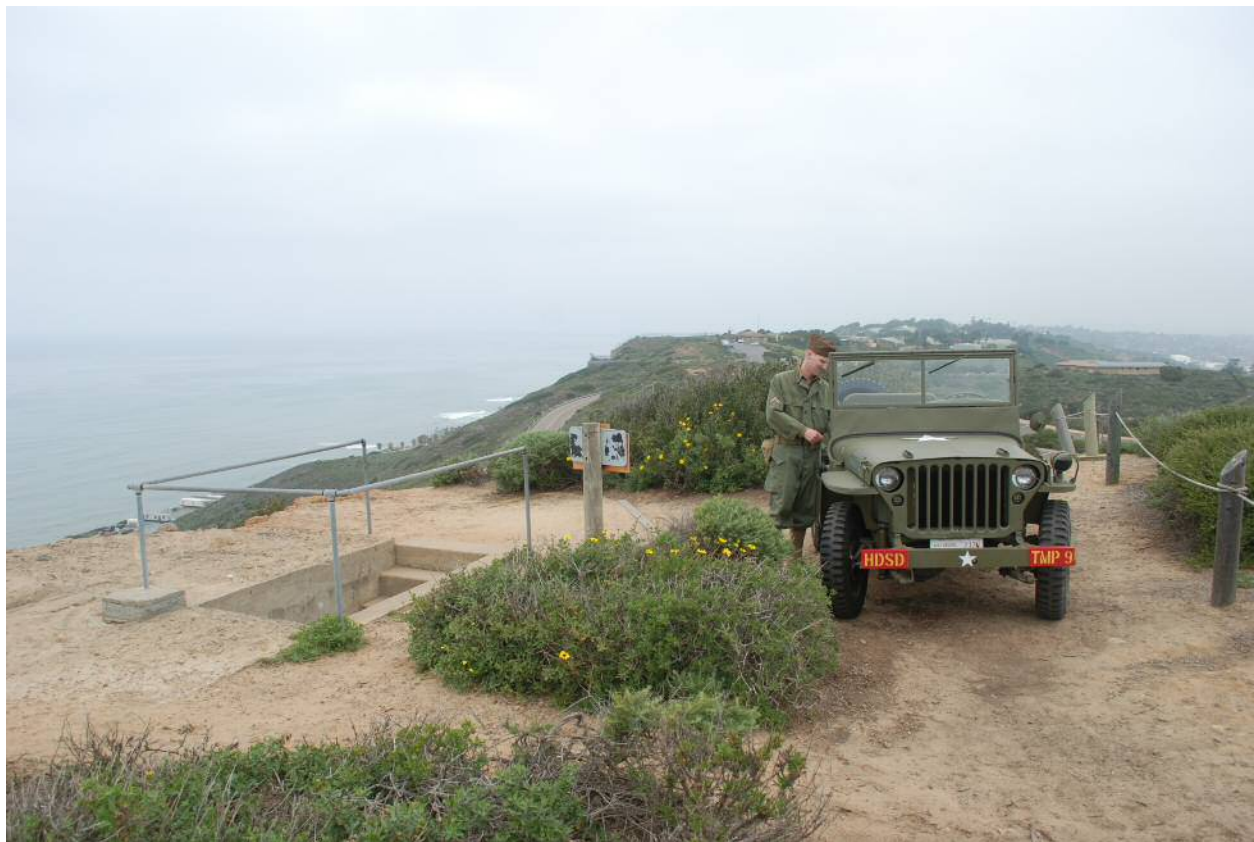
This is the entry to the bunker, looking north with Battery Ashburn visible in the background at the top of the hill. This facility served two purposes; first it was the office of the commanding officer of Battery Ashburn, the second was to generate the targeting data needed to aim the 16 inch guns of this battery.

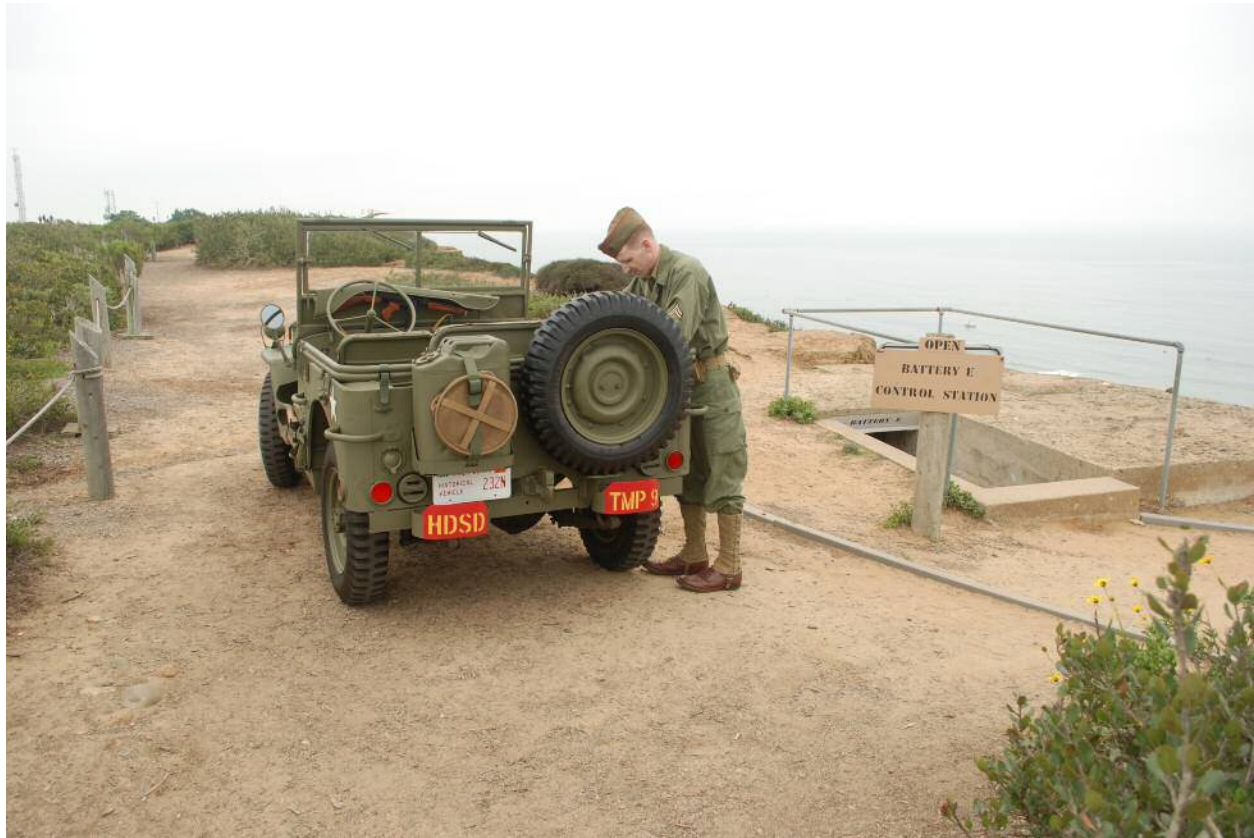
Here is entry to the bunker looking south, with the whale watching station visible in the background, just above the jeep's windshield. The staircase installed in this bunker is a feature unique to this building, the rest of the bunkers in the park are accessed through a ceiling hatch and ladder. The jeep is owned by the person seen working on it here, and is marked as belonging to the Harbor Defenses of San Diego.

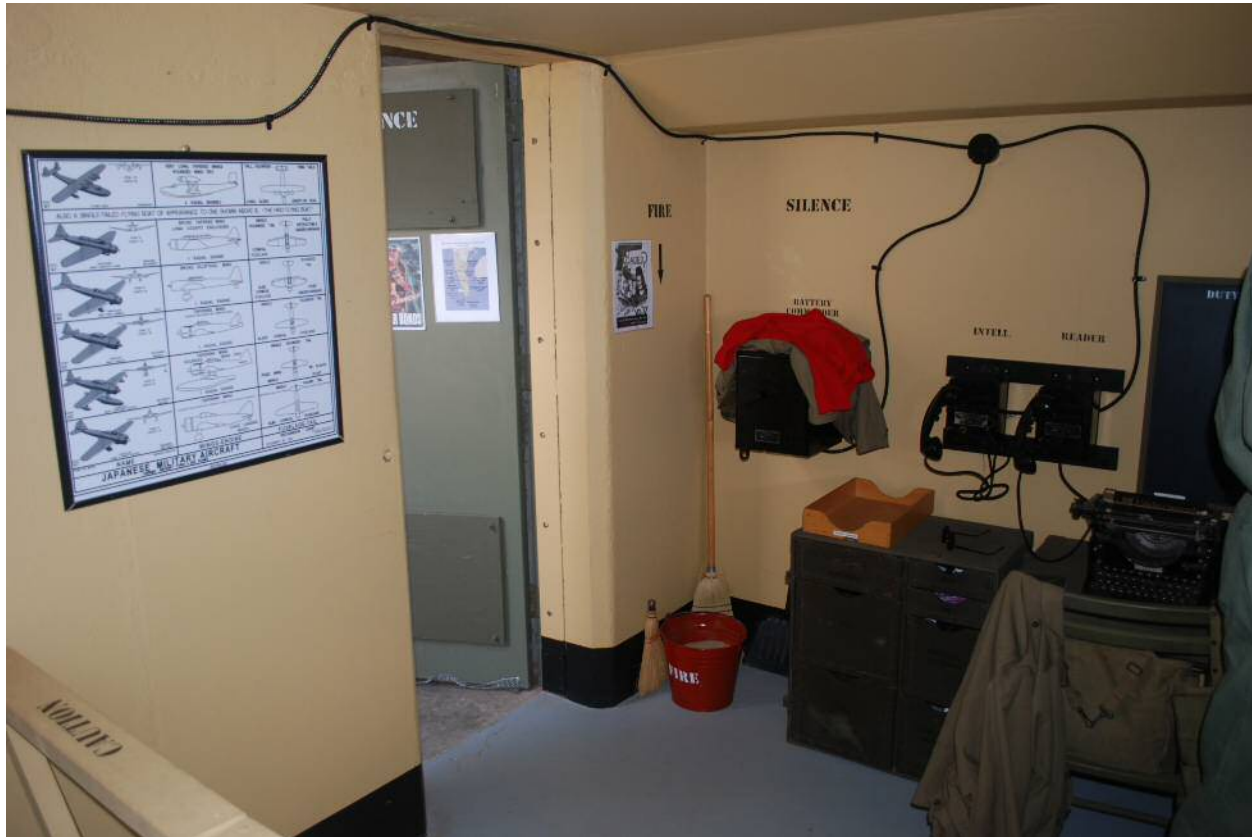
This is inside the bunker, looking southeast at the door at the base of the stairs seen in the last photo. The jacket and shirt is resting on the lock-box secured phone used by the battery commander to issue the order to actually fire the guns of Battery Ashburn. The other phones are used to communicate with the lower bunker and elsewhere. The airplane identification chart is a new reproduction created by one of the bunker volunteers, based on a real World War Two poster.

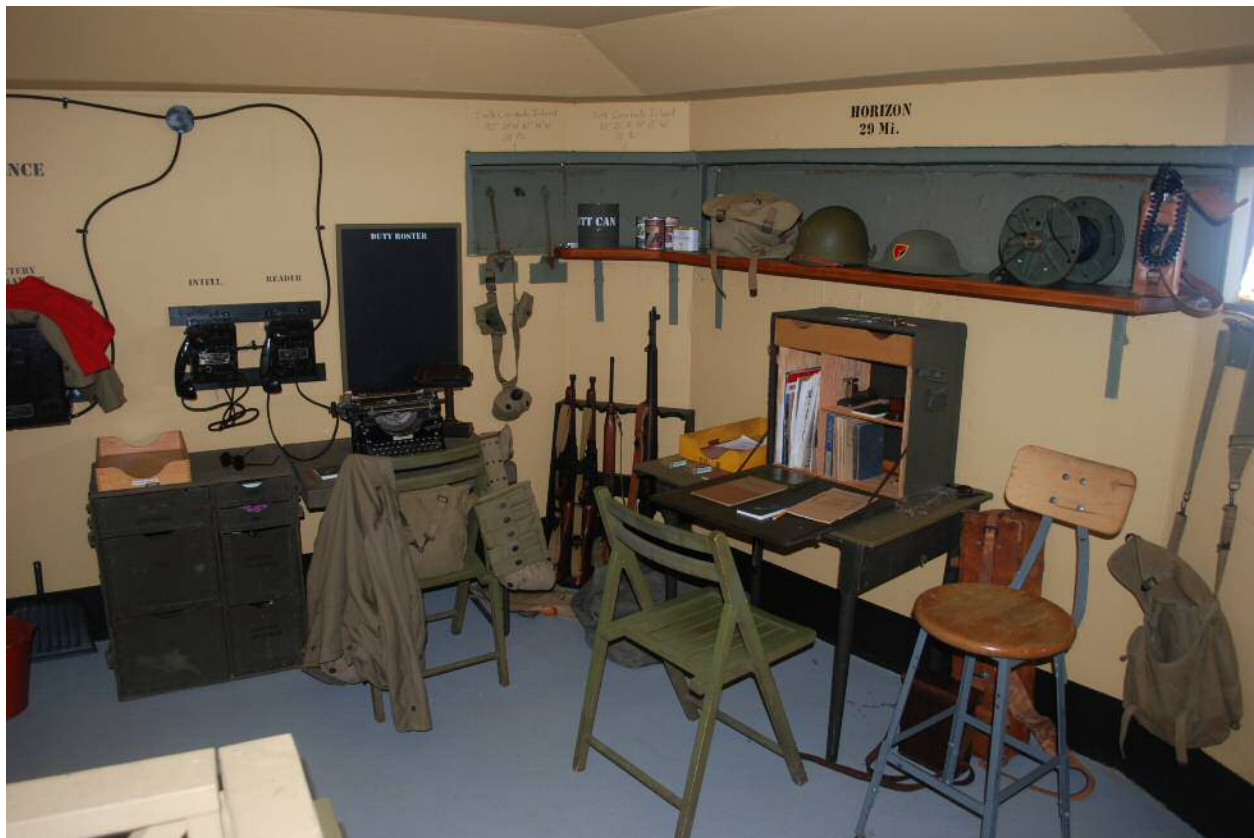
Turning slightly to the right from the previous photo, this shows the desk used by the battery commander and his assistant. This was where the administrative work was done. The items seen here were moved to the north wall when the azimuth scope pedestal (seen on the next page) was installed.

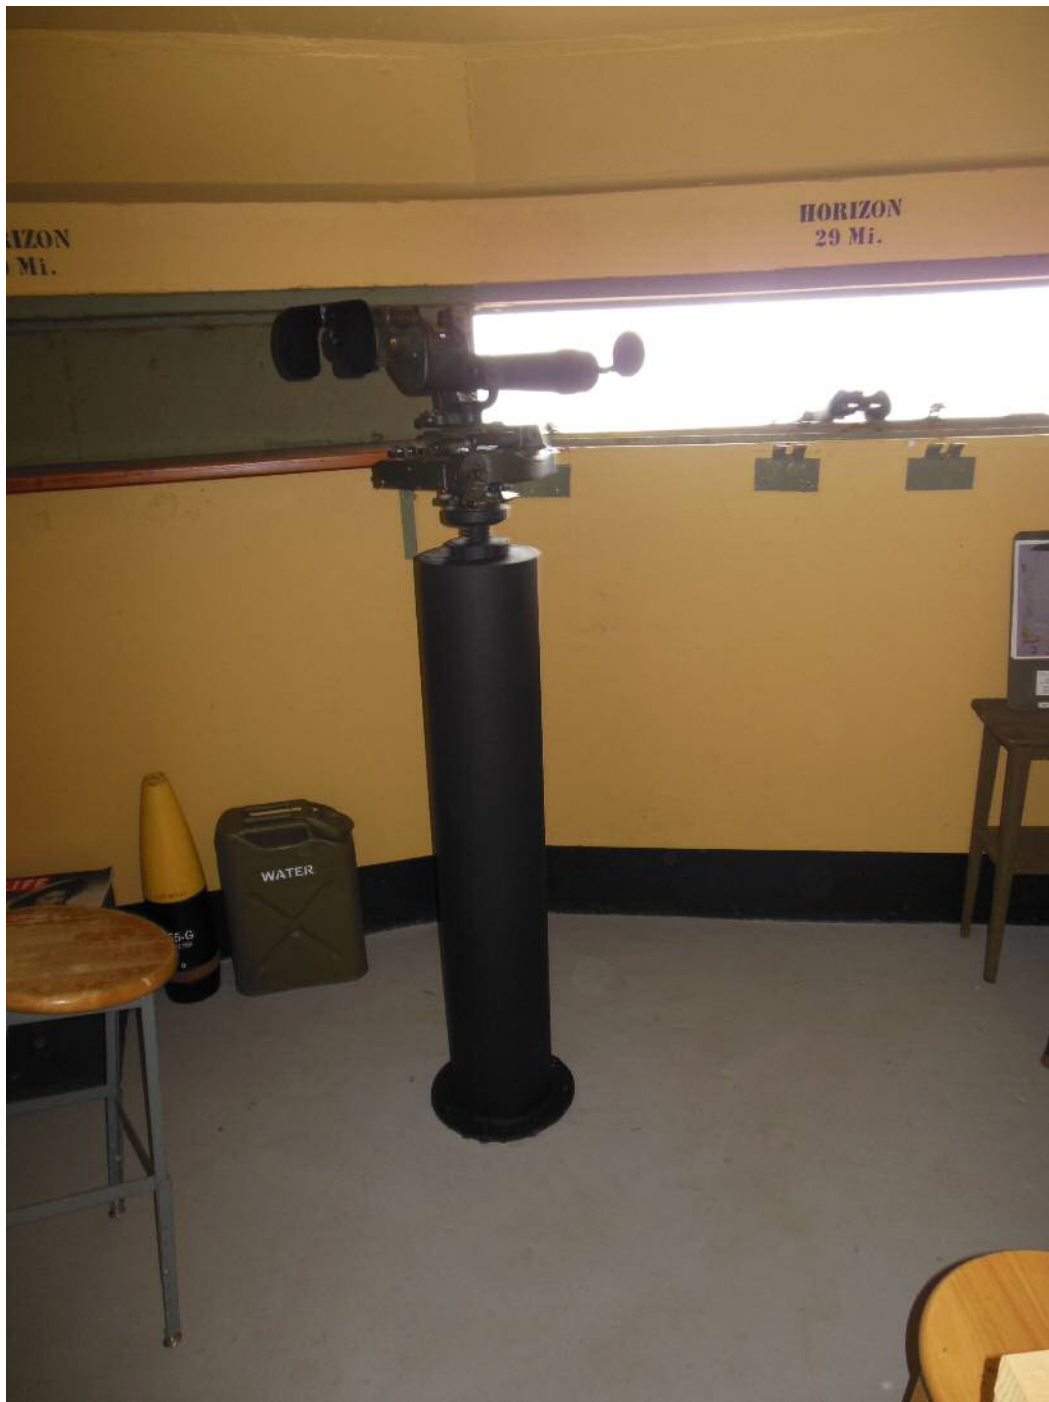
This is the park's M1910 azimuth scope mounted on its newly installed pedestal. This pedestal was recovered from another bunker in the park. The scope is rated at 15 power, which is twice the magnifying power of a normal pair of binoculars.

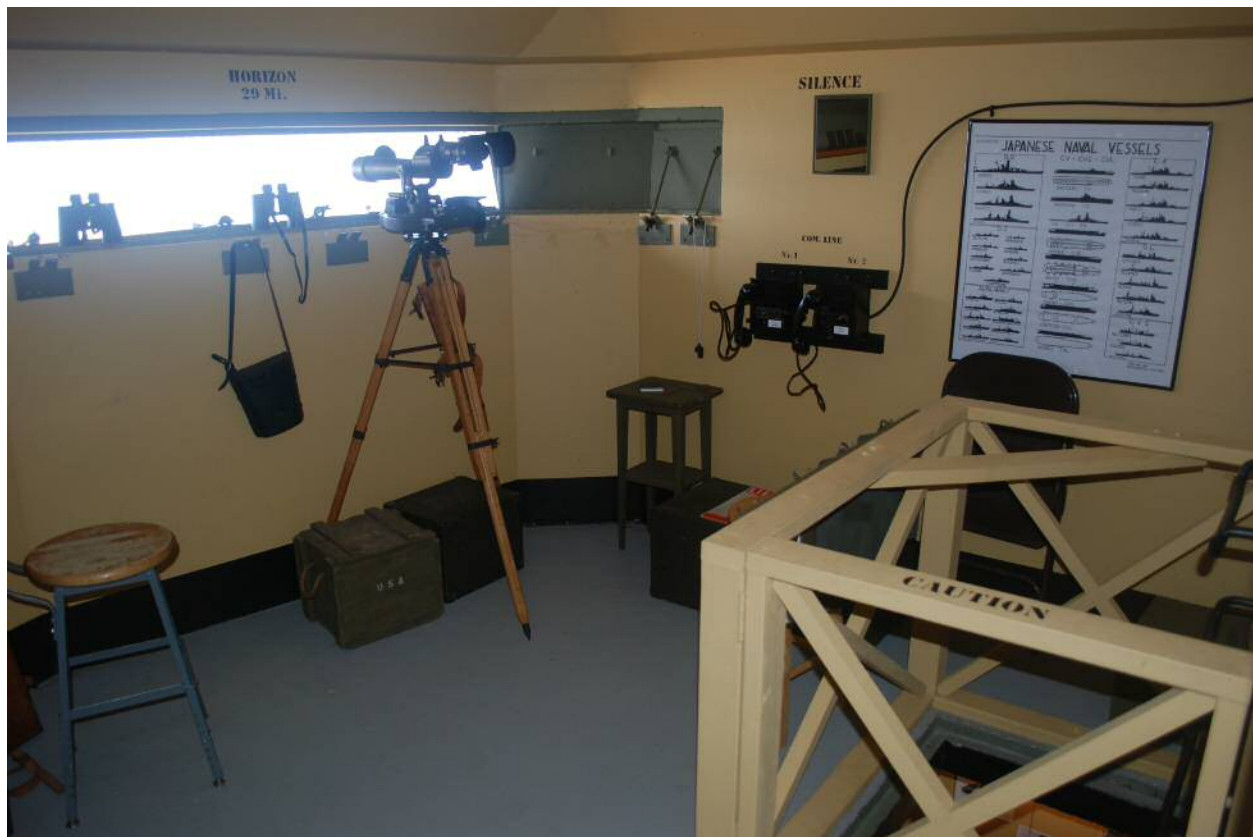
Turning slightly to the right again, this is the northwest wall before the azimuth scope's installation. This shows the wooden tripod that was initially used to demonstrate the function of the azimuth scope. The azimuth scope and the telephone were the most important instruments installed in the bunker. The ship identification chart is another reproduction done by a volunteer.

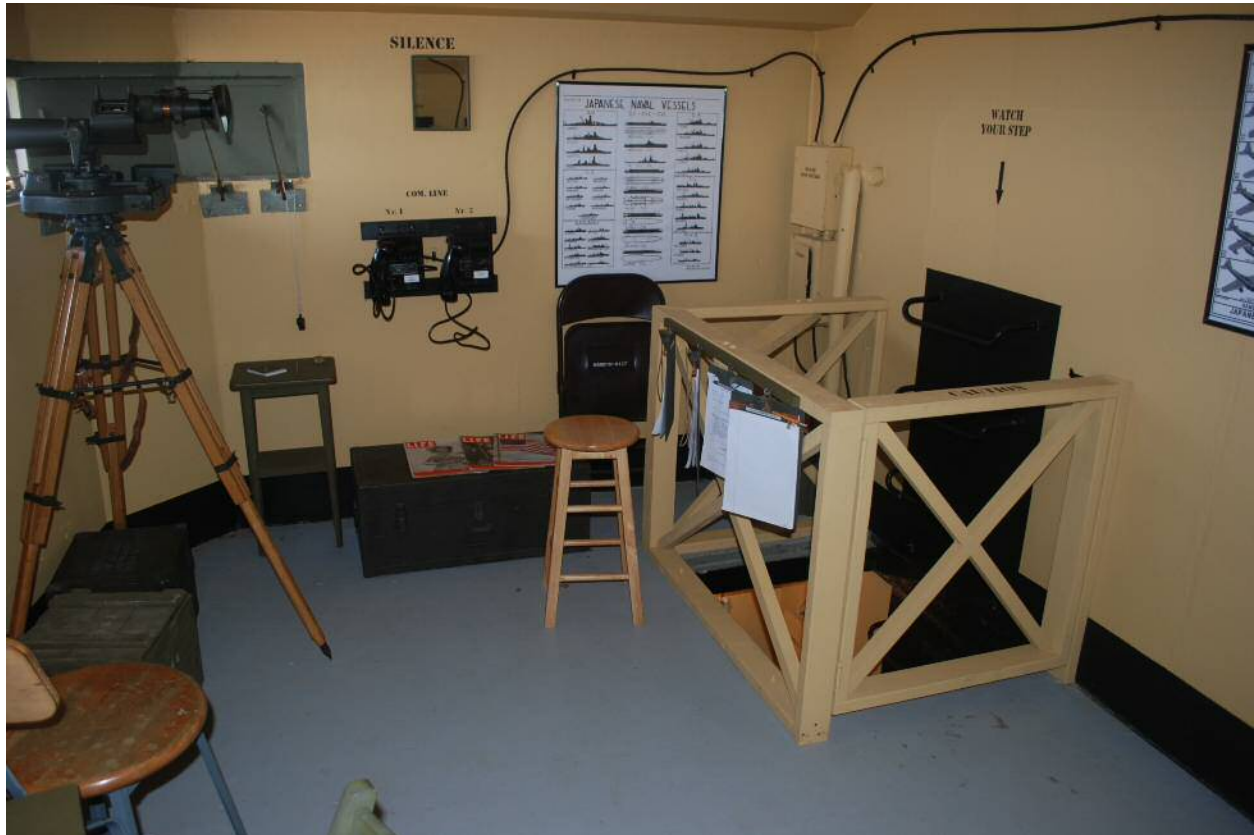
Turning right once again, looking at the northeast corner, shows the ladder leading down to the bunkroom, and the post war electrical panels. Since AC power is no longer available inside the bunker, the wiring has been converted to use 12 volt DC current supplied by a car battery to power the light bulb and telephones.

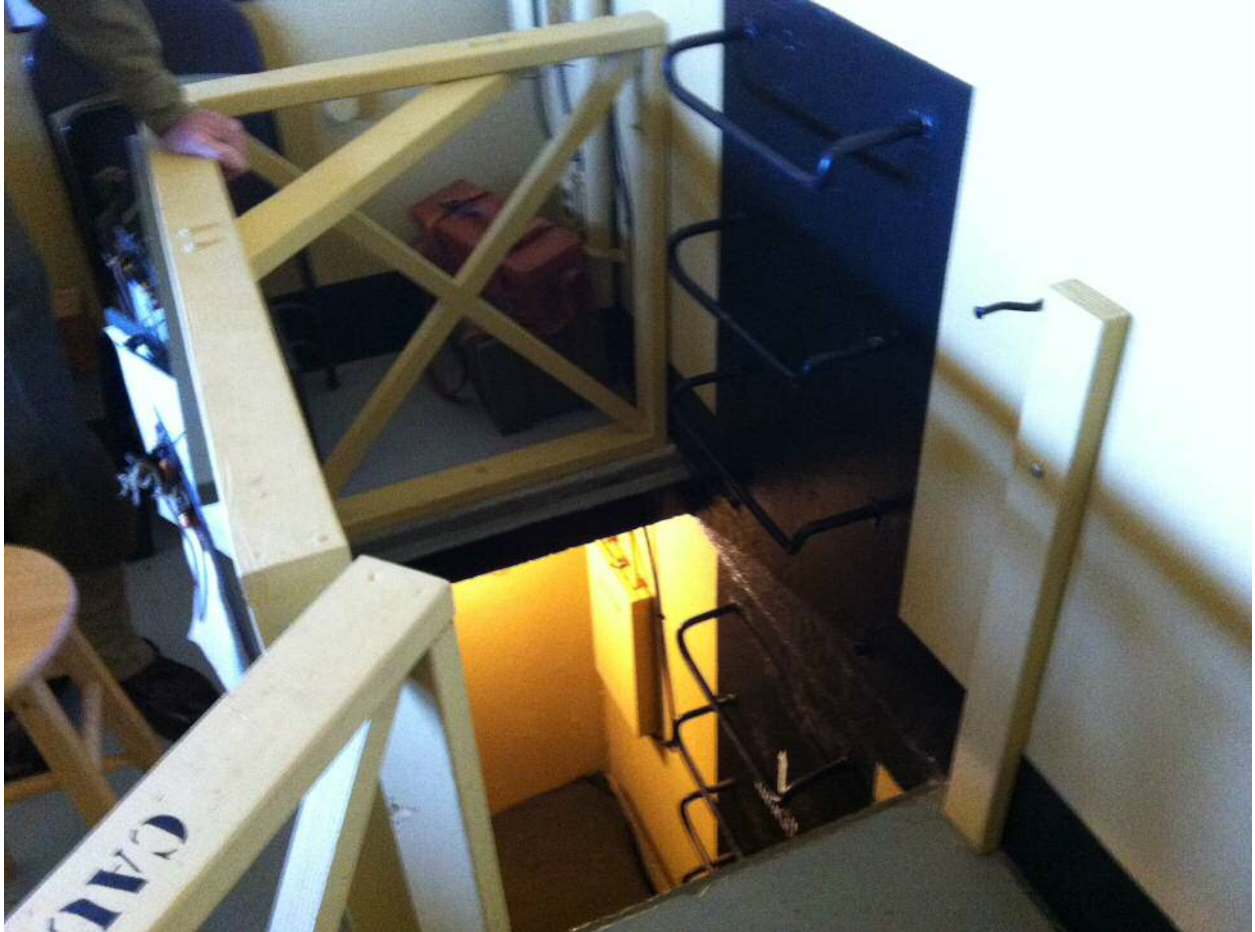
The view down the ladder to the bunkroom. Just visible at floor level is the missing rung, there are two stumps of iron rod sticking out of the wall, where the rung used to be. A hatch can be placed over this opening to close it off. The gate and the railing are both reproduced, but the design is based on the original drawings of the bunker. The railings are installed using the original holes in the concrete where the original woodwork was placed.

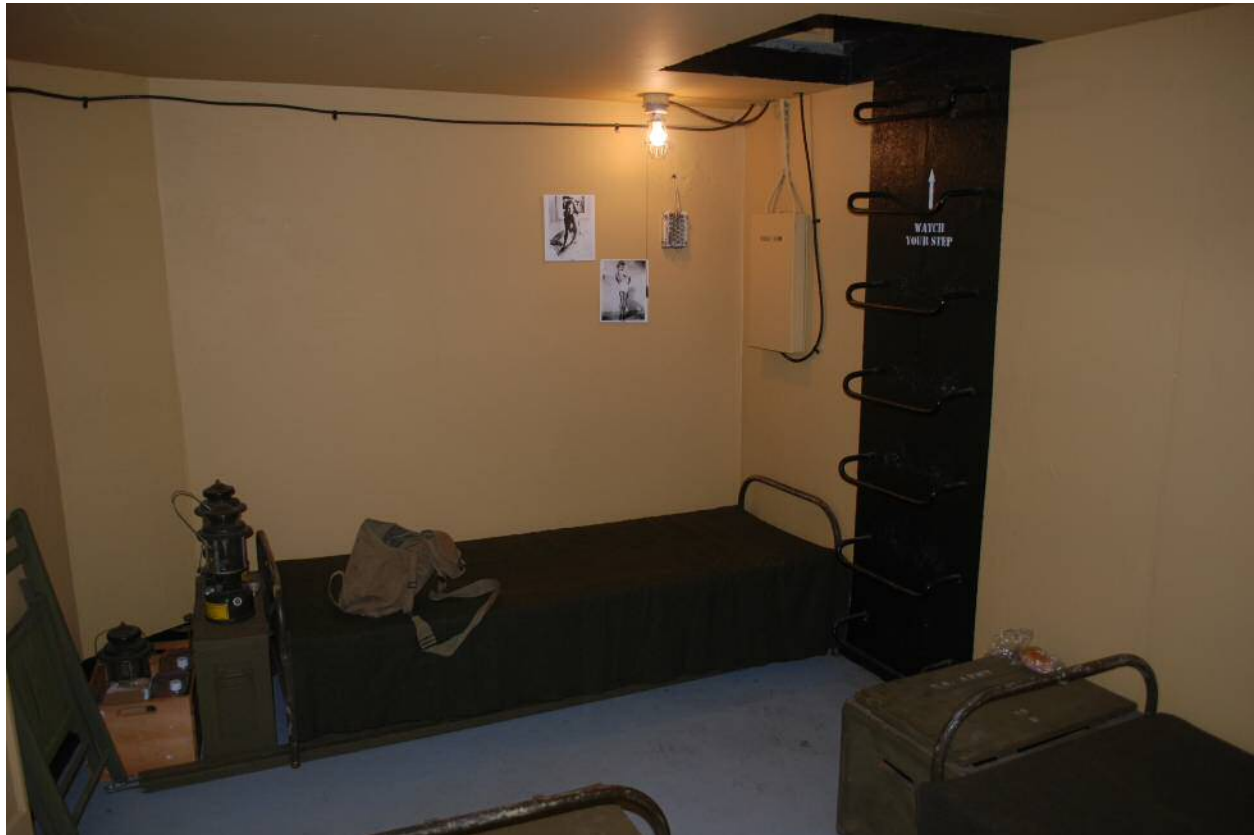
Still looking northeast, but now at the base of the ladder, this is the bunkroom. The light seen here is the only electric light installed in the bunker. The beds are of World War Two vintage, but should be bunk beds, not single beds. The black paint on the wall and along the floor was to hide the scuffmarks of the soldier's boots when they walked around and used the ladder.

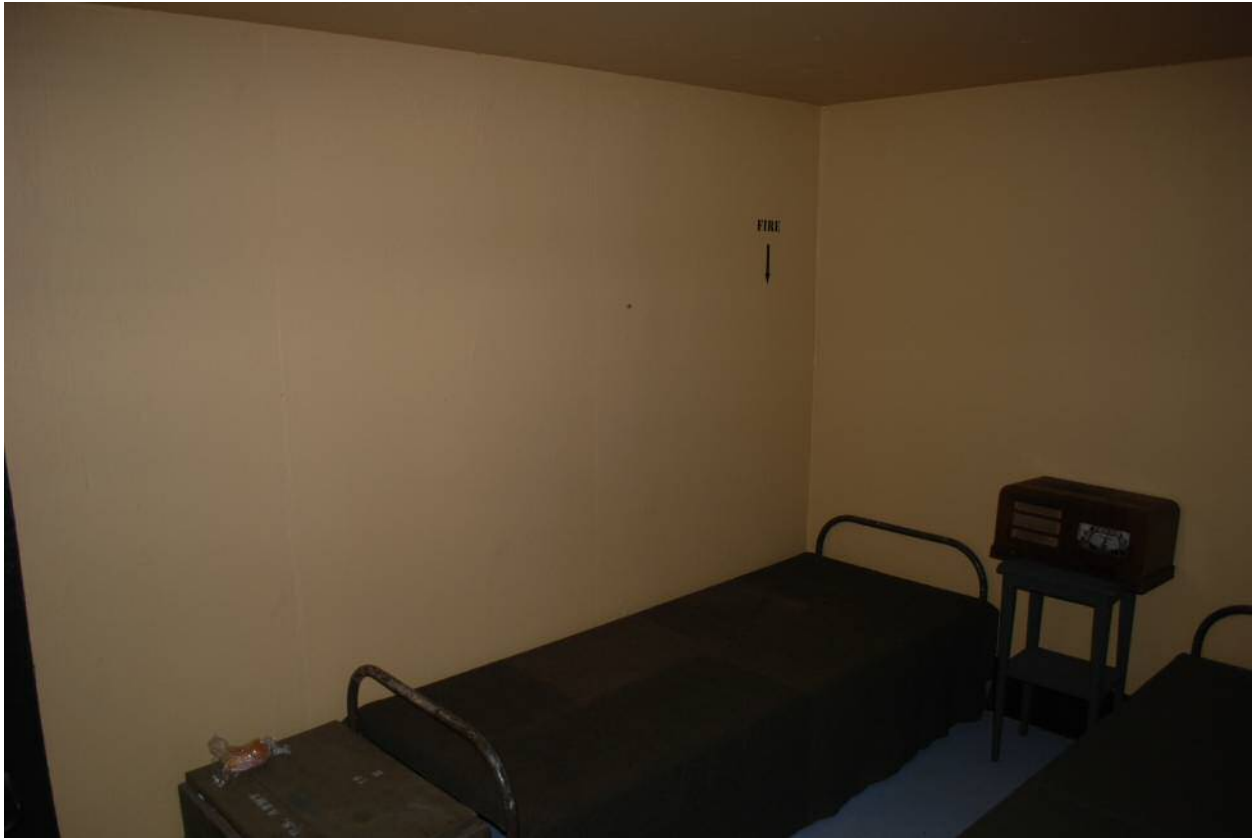
This photo is looking towards the southeast. Not very visible in this shot are slight marks on the wall which suggest that the beds installed in this room were bolted to the wall, rather than placed on the floor. If this is the case, there would be two beds attached to the wall on the left, one above the other.

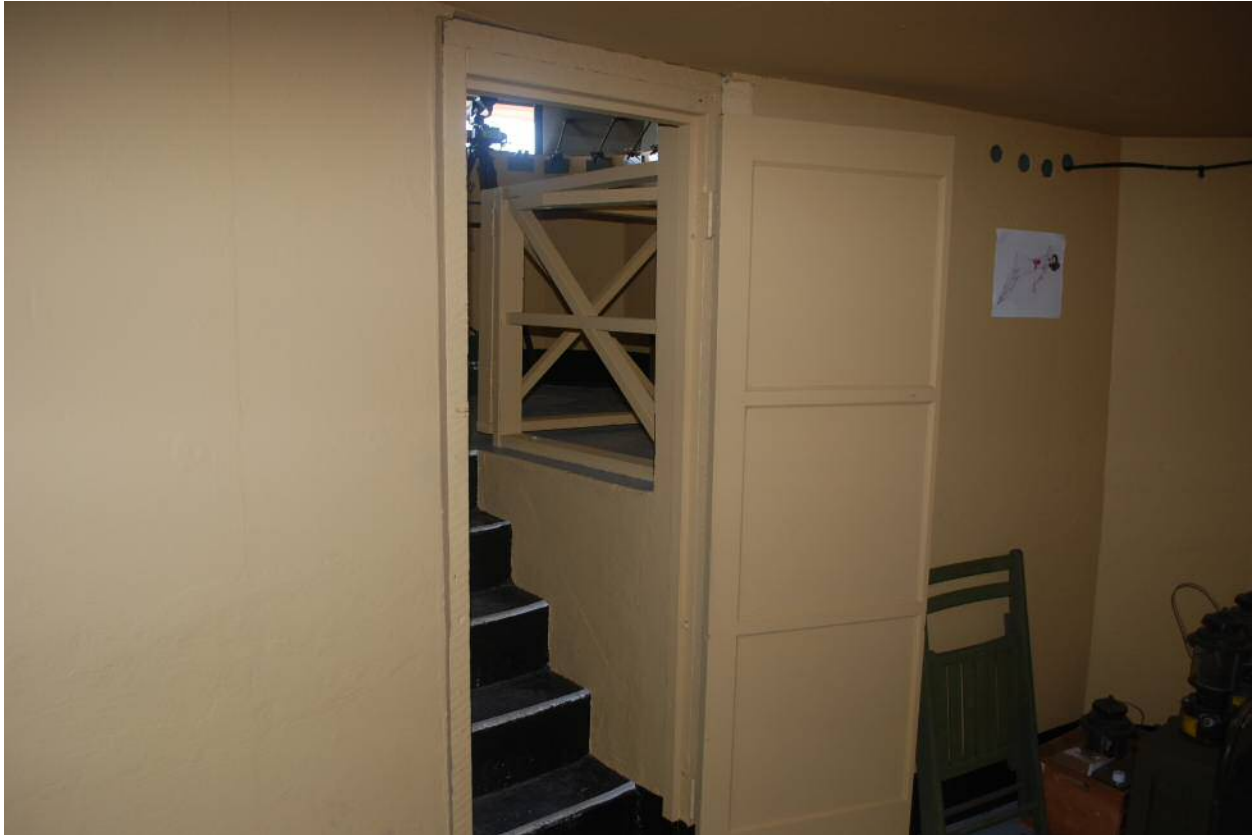
Looking northwest inside the bunkroom shows the doorway leading to the lower bunker. This door was closed at night to prevent any light from the bunkroom from being visible from the view ports of the lower bunker.

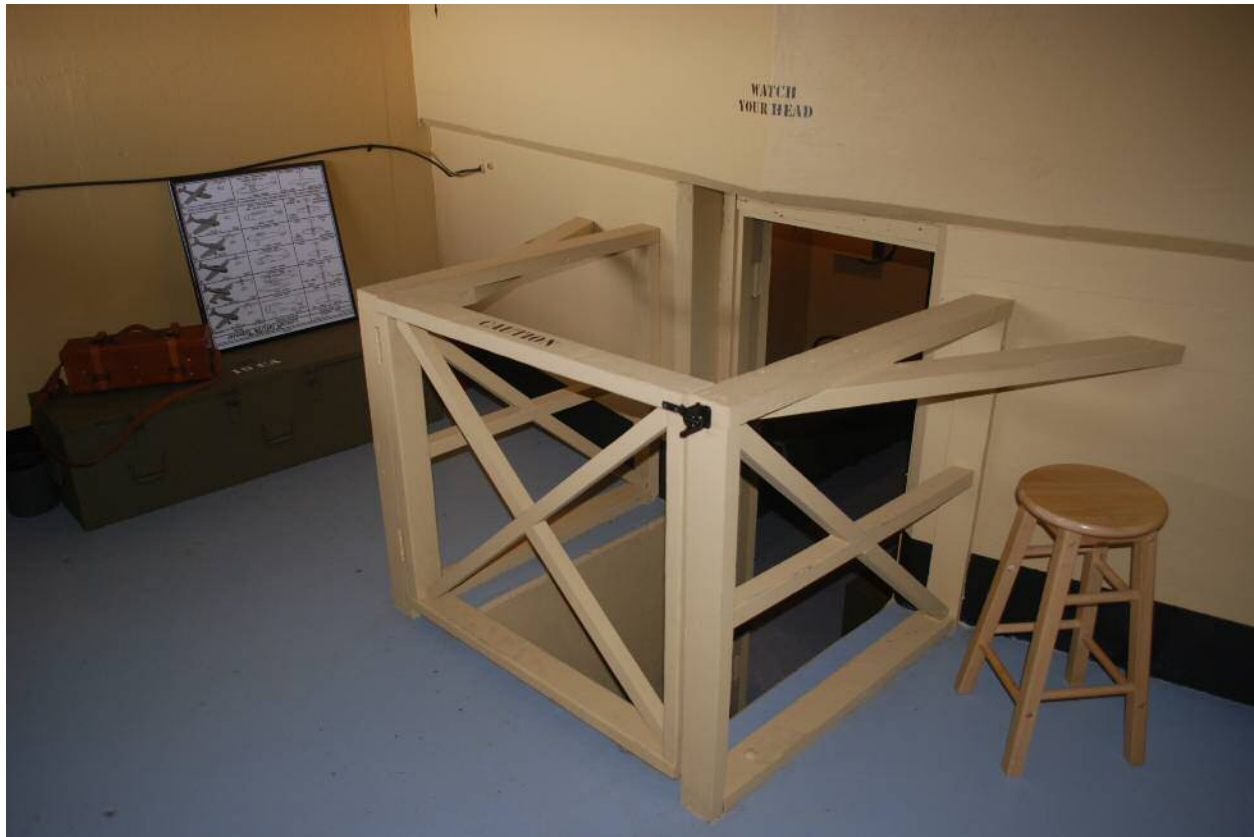
Looking northeast at the top of the stairs seen in the previous picture. The side railings are original, but the gate was reproduced. The original hinges and gate latch were intact when the restoration was started, confirmed that this gate was part of the original design of the bunker.

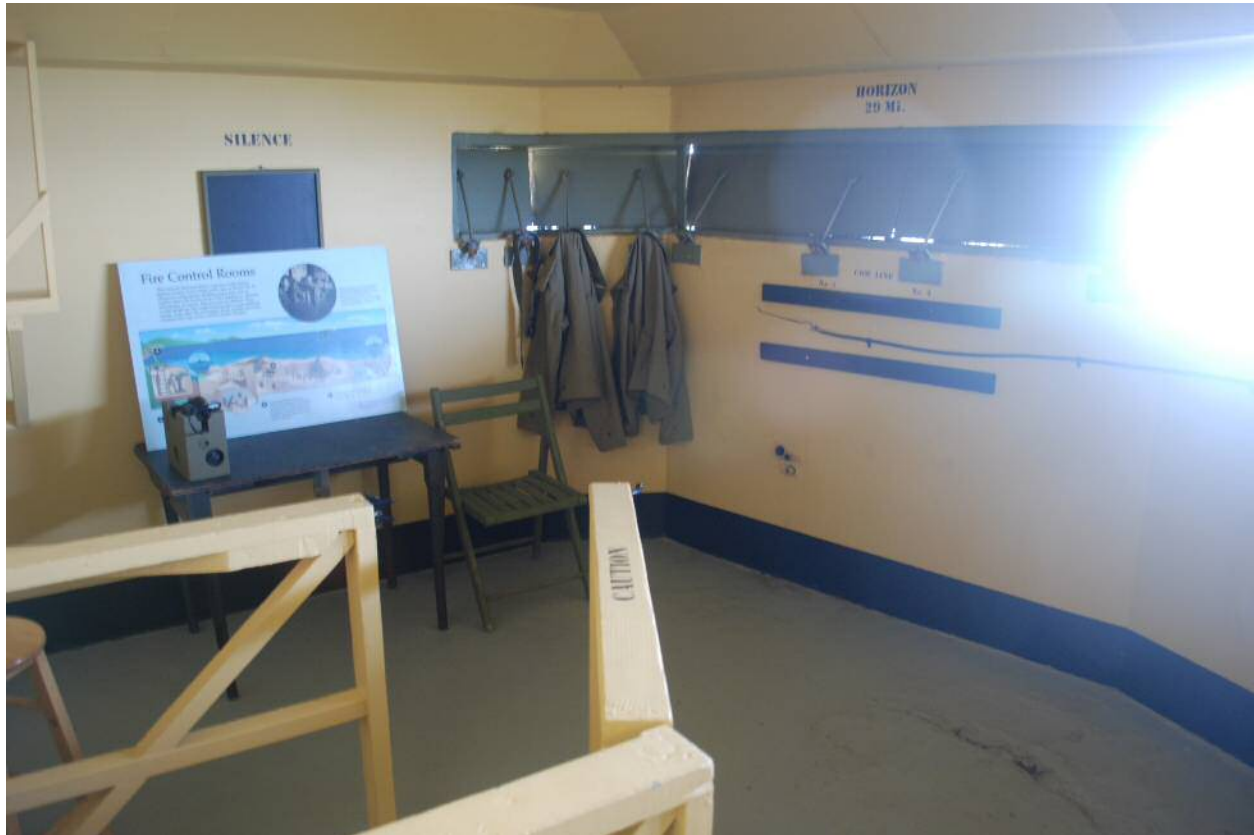
Looking southwest shows the space where two of the three optical instruments were installed on this level. Originally, there were three instruments installed on this level; two azimuth scopes and a depression finder. The lower bunker was the actual base end station, where targets were tracked and the data needed for triangulation was generated.

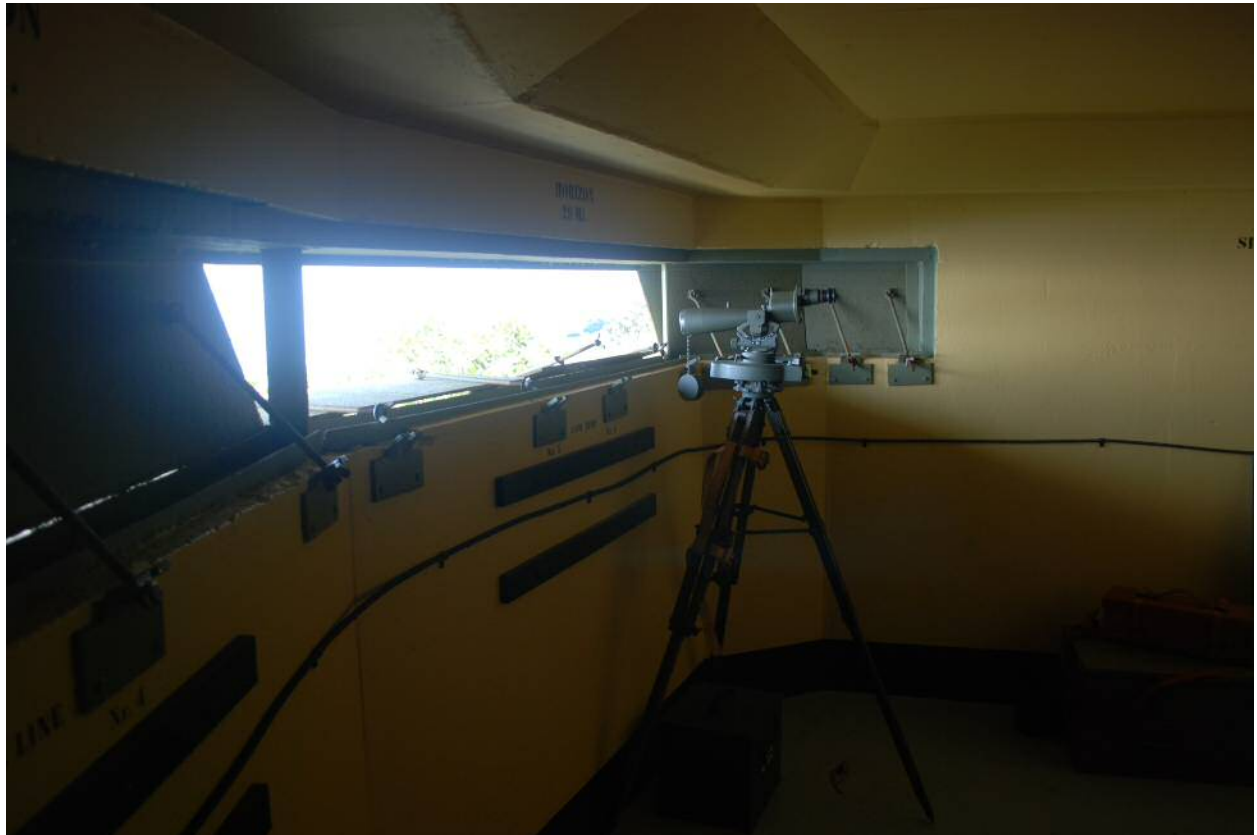
Looking northwest in this room shows the only view port shutters that can be opened, the rest are rusted, or welded, closed. The azimuth scope shown here is located very near where an original pedestal was installed. This scope is a newer model than the scope shown earlier, but it performs the same function. Restoration is ongoing for the lower bunker, and is less complete than the upper level.

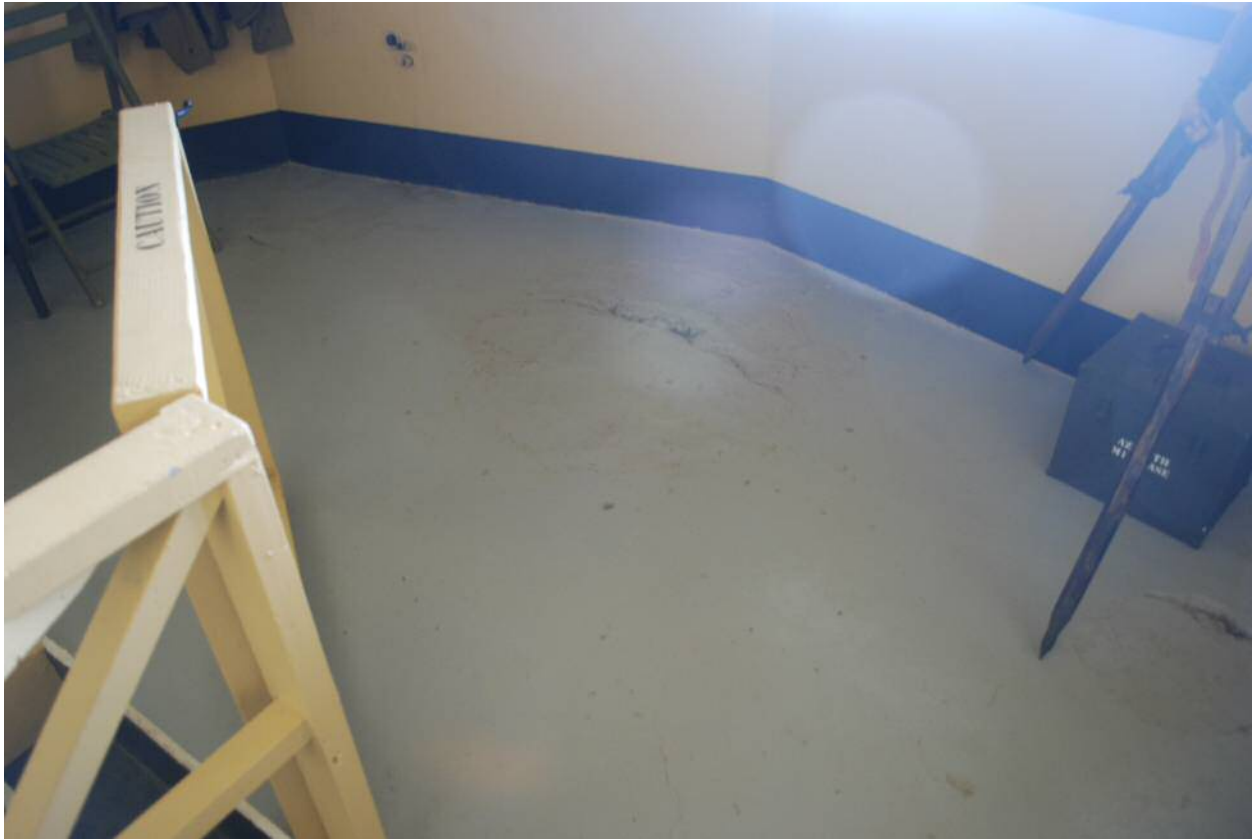
This is the floor of the lower bunker, showing the scars where the original telescopes were mounted. The smaller marks on the left and right were where azimuth scope pedestals were mounted the same as seen earlier. The larger scar in the center was where a depression finder was mounted. The mount was a hexagon of cement about 18 inches high. The black band on the wall at floor level was to hide scuff marks made by soldier's boots.
